Welcome to our September newsletter

Thermography as a tool to detect energy-saving opportunities in cold chain equipment

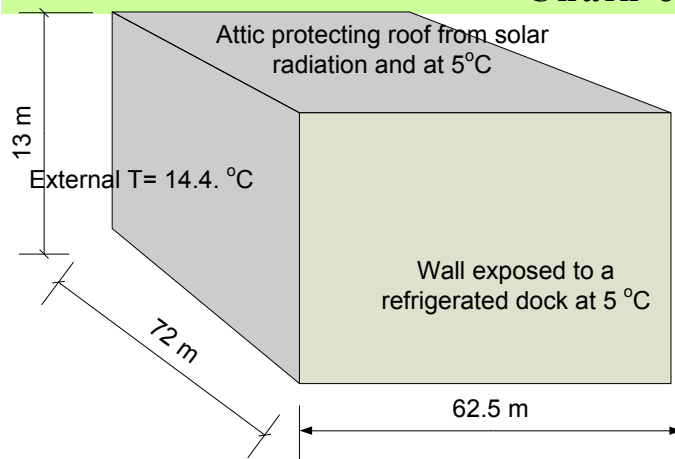
FIG. 1. Hypothetical cold store used in the heat leakage case study.
Note: only panels in sidewalls and roof were considered. The concrete floor is a special case not considered in this study.

- Frozen cold store used 344 days per year, 24 hrs/day.
- Walls and ceiling made on sandwich panel (insulation thickness = 200 mm in sidewalls and 250 in ceiling).
- External cladding, thus avoiding direct solar radiation.
- One wall (62.5 m x 13 m) is exposed to a refrigerated dock at 5 °C.
- An attic protects the roof from solar radiation.
- Convective currents from the coldstore to the attic lower the external temperature to about 5°C in the roof.
- Three walls are exposed to an ambient temperature of 14.4°C (which is the average annual temperature in Laverton VIC).
- Cold store temperature= -23 °C.
- COP = 2
- Electricity costs = \$0.14/kWh.

The cold store case study in this article is a facility with the characteristics shown in Figure 1. Figures 2a and 2b show the heat leakage and energy costs (in AUD and carbon emissions) assuming a range of k_{values} , from the "best practice" insulation effectiveness factor for a frozen cold store [9] to the value expected from a 10-15 year old cold store with insulation damage.

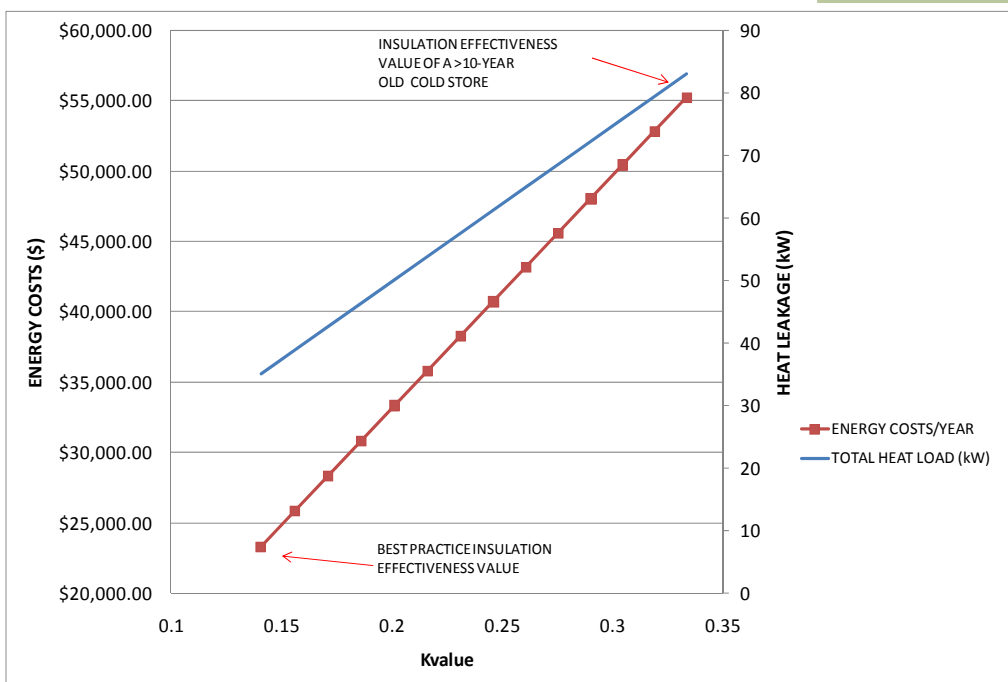
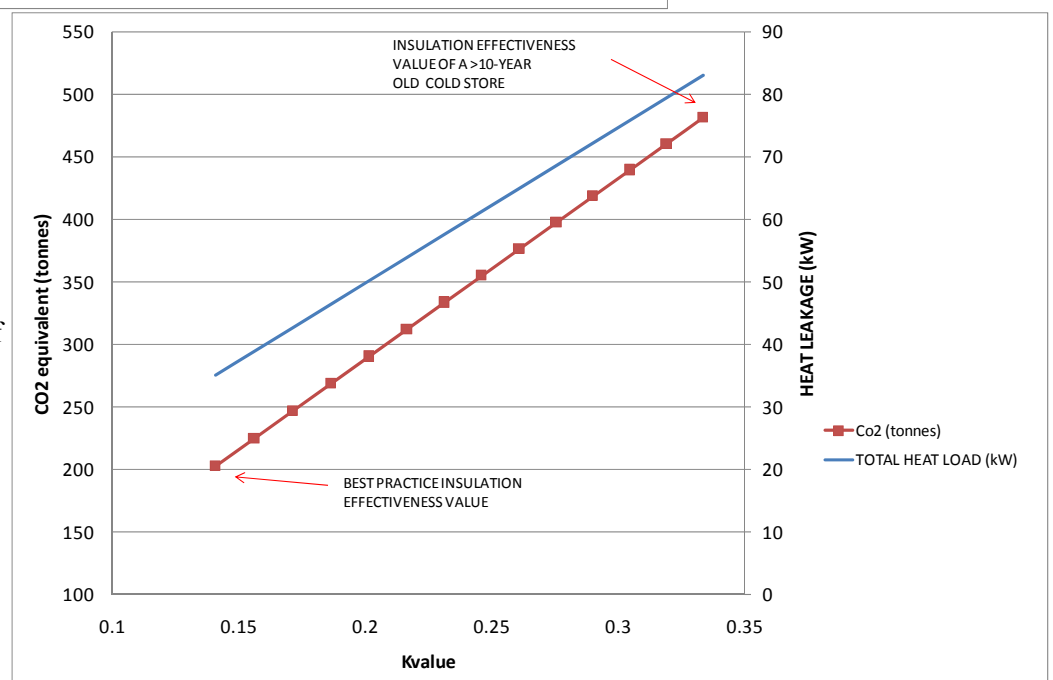
FIG. 2a (left). Electricity costs arising from heat leakage through the envelope of the frozen cold store described above, at various levels of insulation effectiveness (k_{value} , W/m² K). The best practice k_{value} is representative of a new cold store with a typical degree of thermal bridging introduced during construction. A k_{value} above 0.33 is representative of a 10-15 year old cold store for frozen products.

FIG. 2b (right). Carbon emissions arising from heat leakage of the frozen cold store described above, at various levels of insulation effectiveness (k_{value} , W/m² K). The best practice k_{value} is representative of a new cold store with a typical degree of thermal bridging introduced during construction. The highest carbon emissions were found for a k_{value} representative of a 10-15 year old cold store.

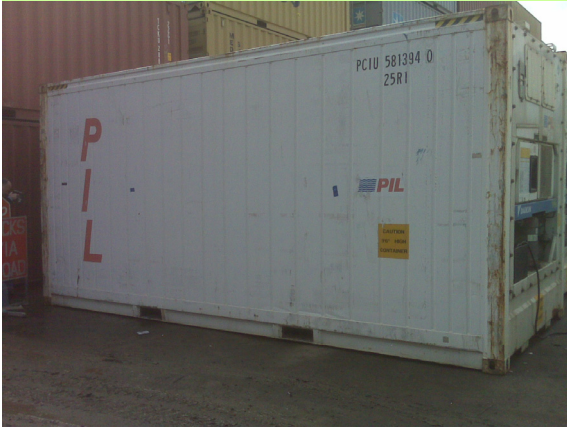
FIG. 3. Container used in the heat leakage case study.

- ISO 20 ft frozen container used a cumulative 260 days per year, 24 hrs/day.
- K_{value} (new) = $0.4 \text{ W/m}^2 \text{ K}$
- Exposed to an average ambient temperature of 21°C .
- Internal temperature = -18°C .
- A ratio of cooling capacity-to-power consumed of 0.93 (which includes energy use by ancillaries) was assumed.
- External dimensions: 6 m (L) x 2.42 m (W) x 2.38 m (H)
- Insulation thickness:
 - Slides and door = 70 mm
 - Roof = 100 mm

The characteristics of the container used in this case study are shown in Figure 3. Figures a and 4b show the heat leakage and energy costs in USD and carbon emissions^b respectively, assuming a range of k_{values} , from the "best practice" insulation effectiveness factor for a container [9] to the value expected from a 10-15 year old container with insulation damage.

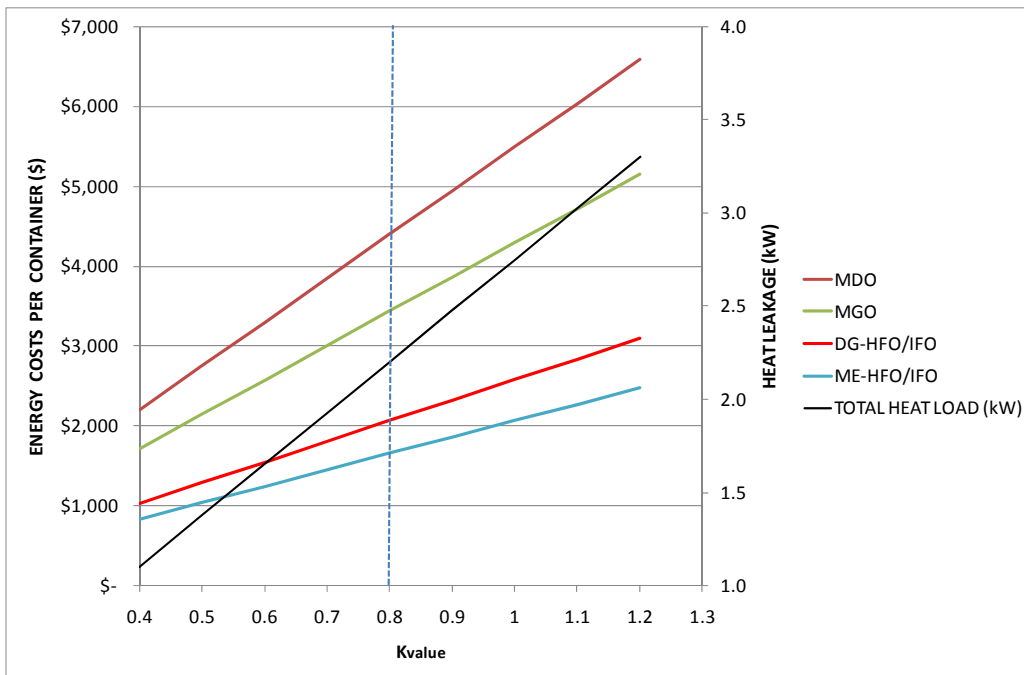
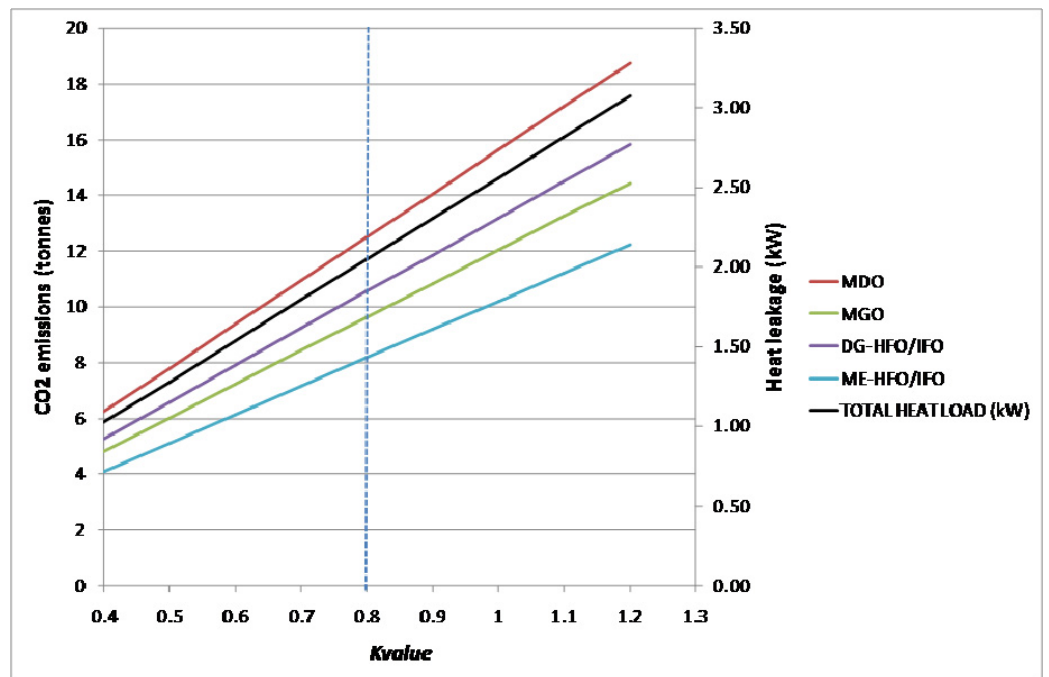
Fig. 4a (left). Annual energy costs arising by heat leakage in a frozen 20 ft container, at various levels of insulation effectiveness (k_{value}). The best practice $k_{value} = 0.4 \text{ W/m}^2 \text{ K}$ is representative of a new container with a typical degree of thermal bridging introduced during construction. A $k_{value} = 0.8 \text{ W/m}^2 \text{ K}$ is representative of the normal ageing of the insulation after 15 years of use. A $k_{value} = 1.2 \text{ W/m}^2 \text{ K}$ is representative of a +15-year old container with insulation damage.

Fig. 4b (left). Annual carbon emissions arising from heat leakage in a frozen 20 ft container, at various levels of insulation effectiveness (k_{value}). The best practice $k_{value} = 0.4 \text{ W/m}^2 \text{ K}$ is representative of a new container with a typical degree of thermal bridging introduced during construction. A $k_{value} = 0.8 \text{ W/m}^2 \text{ K}$ is representative of the normal ageing of the insulation after 15 years of use. A $k_{value} = 1.2 \text{ W/m}^2 \text{ K}$ is representative of a +15-year old container with insulation damage.

Notes: MDO= mobile diesel generator using marine diesel oil; MGO= mobile diesel generator using marine gas oil; DG-HFO/IFO= Diesel generator using fuel oils; ME-HFO/IFO= Main engine with shaft generator using fuel oils. Costs in US dollars.

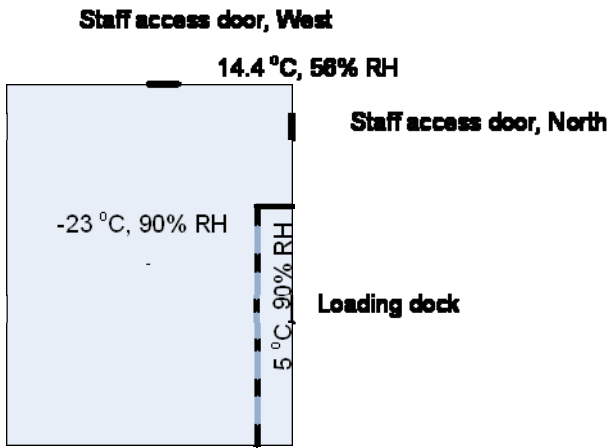
FIG. 5. Hypothetical cold store used in the air leakage case study.

- Frozen cold store used 344 days per year, 24 hrs/day.
- Doors opened during a cumulative period of 15 days during the year.
- There are two staff access doors (0.8 m x 2 m) that lead to the exterior part of the building at ambient conditions (14.4°C and 56% relative humidity).
- Further, there are five sliding doors (2.3 m x 2.7 m) that lead to a refrigerated dock at 5 °C and 90% RH.
- The seals for both staff access doors and sliding doors have a thickness of 2 cm.
- Cold store temperature= -23 °C.
- COP = 2
- Electricity costs = \$0.14/kWh.

Figure 5 shows a plane view of the cold store case study (also presented in Fig.1) and relevant data used in the air leakage calculations. Figures 6a and 6b show the heat load and energy costs in AUD and carbon emissions, respectively as functions of the % gap.

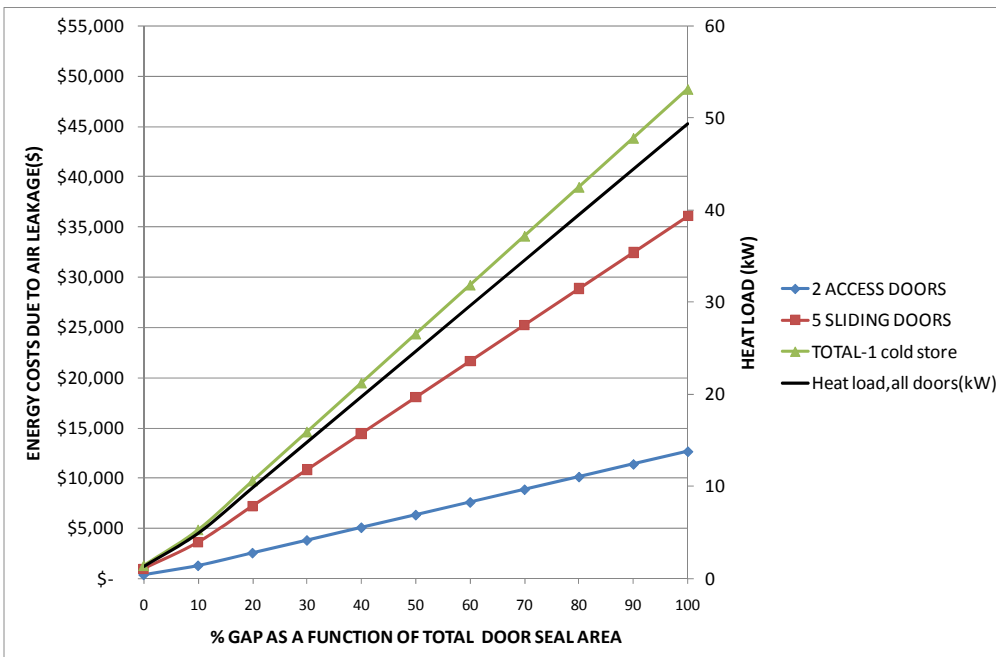
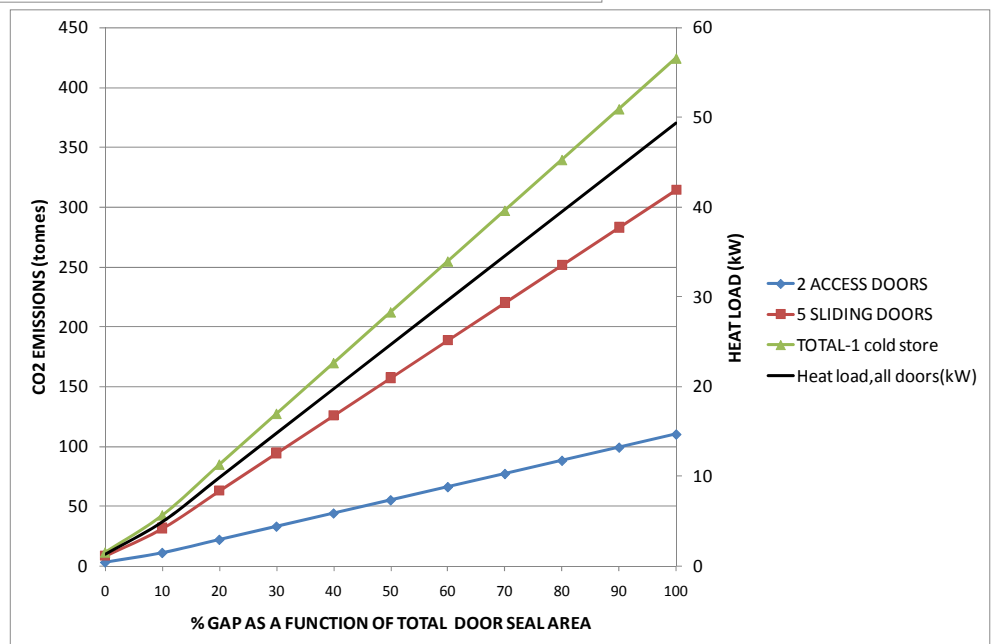
FIG. 6a (left). Electricity costs arising from air leakage through the door seals in a frozen cold store, at various levels of leakage. The blue line is the estimation of energy costs due to leakage through two 0.8 m x 2 m access doors; the red line represents the costs of air leakage through five 2.3 m x 2 m sliding doors. The green line represents the total energy costs due to air leakage in all doors.

FIG. 6b (right). Carbon emissions arising from air leakage through the door seals in a frozen cold store, at various levels of leakage. The blue line is the estimation of energy costs due to leakage through two 0.8 m x 2 m access doors; the red line represents the costs of air leakage through five 2.3 m x 2 m sliding doors. The green line represents the total energy costs due to air leakage in all doors.

Note: the best practice air infiltration value was set at 0.0022 m³/s, in view of the conclusions of Chen et al. [12], which observed that the air leakage per length of door seals for sliding doors with seals in good condition was about 0.0004 to 0.0008 m³/s m.

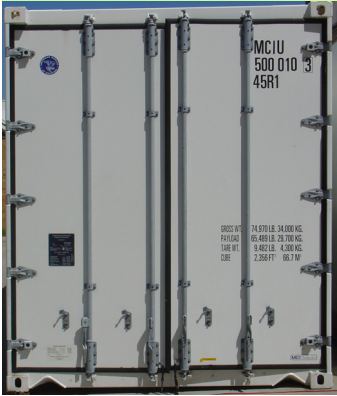
- 20 ft frozen container used a cumulative 260 days per year, 24 hrs/day (utilization rate = 72%).
- Exposed to an average ambient temperature of 21°C and RH of 60%.
- Internal temperature= -18 °C and RH=90%.
- Door dimensions = 2.38 m(W) x 2.18 m (H) with a total seal area of 0.182 m² (seal thickness= 0.02 m)
- A ratio of cooling capacity-to-power consumed of 0.93 (which includes energy use by ancillaries) was assumed.

FIG. 7. Container used in the heat leakage case study.

Figure 7 shows the container case study and data used to assess the air infiltration through door seals. Figures 8a and 8b show the heat load and energy costs in USD and carbon emissions, respectively as functions of the % gap.

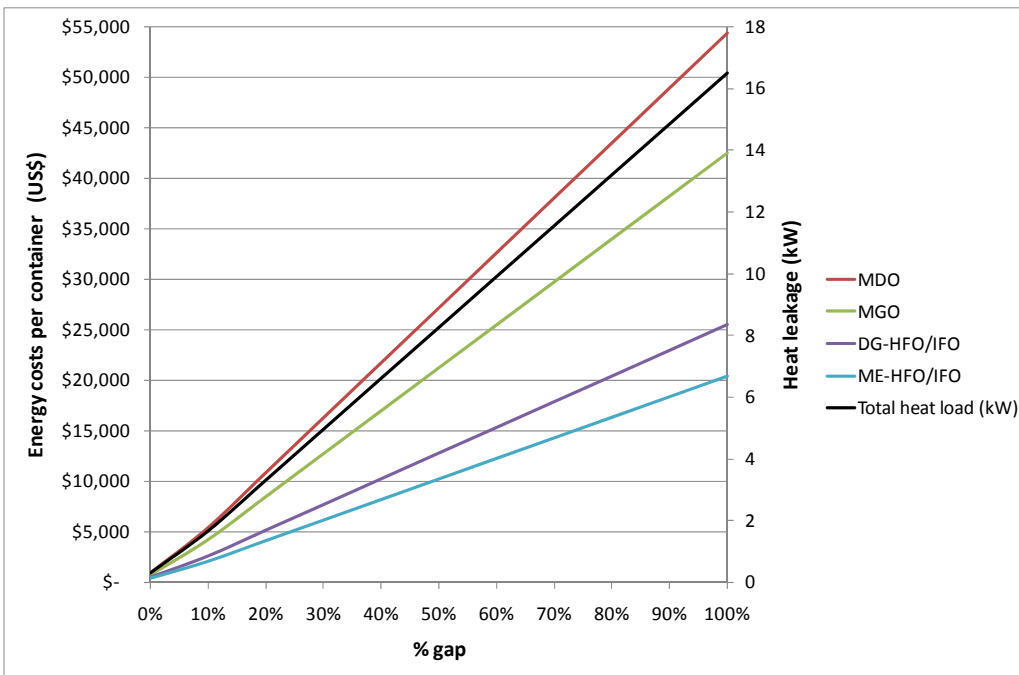
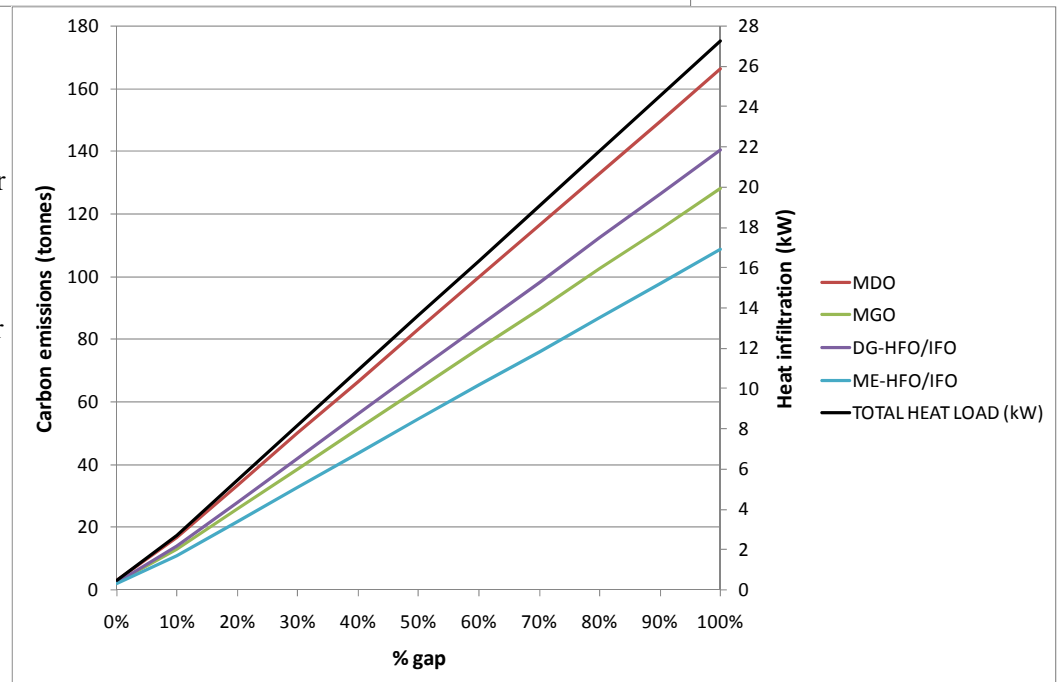
Fig. 8a (left). Annual energy costs arising from air leakage in a frozen 20 ft container, at various % gap factors. The “best practice” air leakage rate is equivalent to 10 m³/h, which is the accepted maximum leakage in the ISO 1492 standard for thermal containers. Leakages over this initial value are all representative of damaged door seals in containers.

Fig. 8b (left). Annual carbon emissions arising from air leakage in a frozen 20 ft container, at various % gap factors. The best practice air leakage rate is equivalent to 10 m³/h, which is the accepted maximum leakage in the ISO 1492 standard for thermal containers. Leakages over this initial value are all representative of damaged door seals in containers.

Notes: MDO= mobile diesel generator using marine diesel oil; MGO= mobile diesel generator using marine gas oil; DG-HFO/IFO= Diesel generator using fuel oils; ME-HFO/IFO= Main engine with shaft generator using fuel oils. Costs in US dollars.
